File No.: 45799

The Tapawera & Districts Community Council (TDCC) Incorporated.
95 Main Road,
TAPAWERA 7096

Detailed seismic assessment of existing building – 95 Main Road, Tapawera

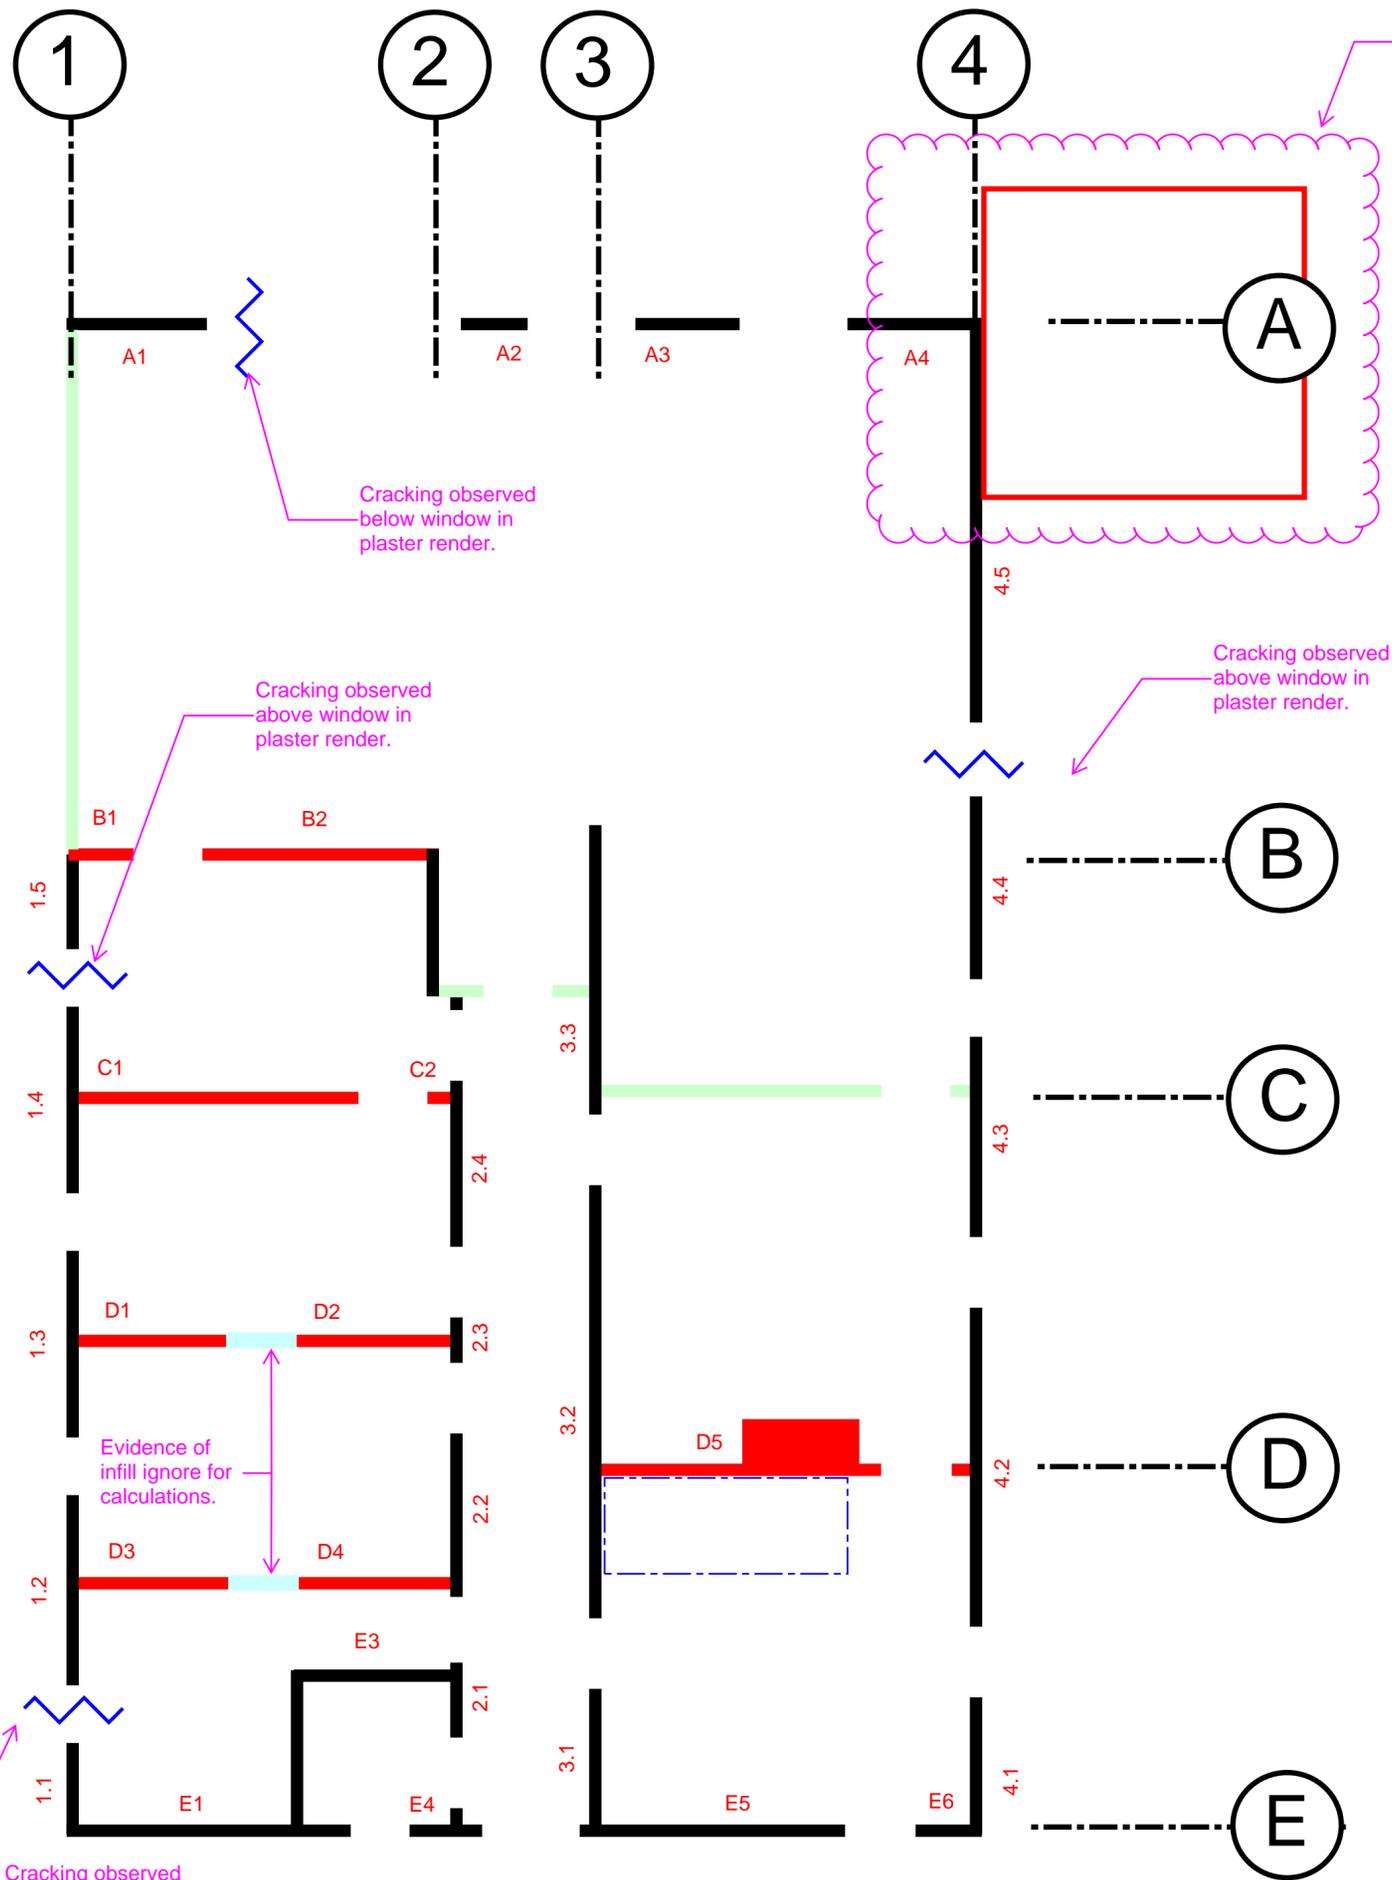
Damage is crack without the wall below window level. It is unclear if wall is still concrete as this window was a later add on.

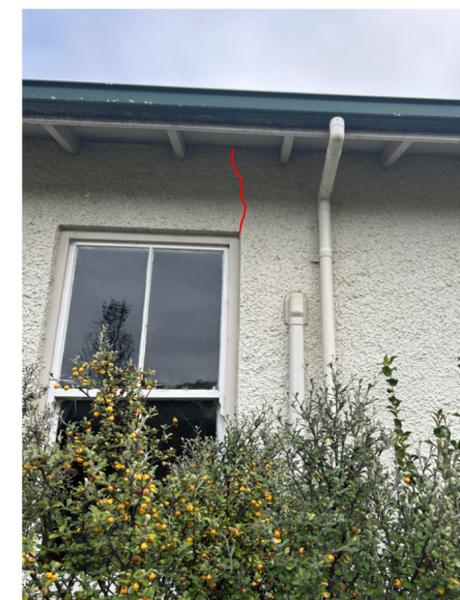
Damage appears to show differential movement between the concrete and timber wall sections. This may be due to insufficient connections at roof/wall level.

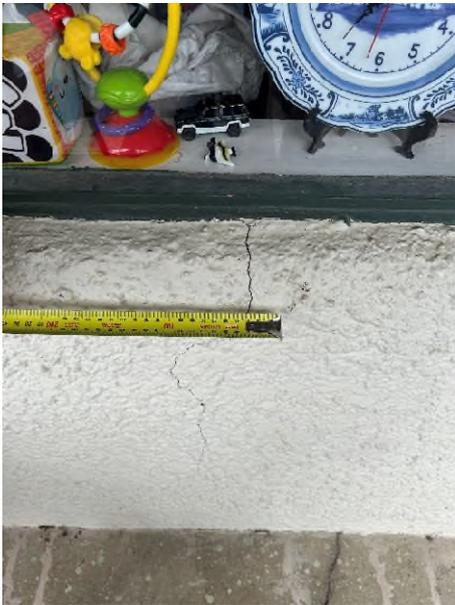
- Cracking (up to 1 mm) along external boundary walls (Northern, Eastern and Western) in the plaster render. While the cracking was only visible in the plaster render, it may continue into the concrete walls.

Photo 3 – External Damage

- We recommend that the cracking observed to the external plaster render is examined further on site to determine if this continues into the concrete element. Any minor cracking within a concrete element shall be repaired by injection with a suitable epoxy resin. The design details of this repair are not within the scope of this report.
