File No.: 45799

The Tapawera & Districts Community Council (TDCC) Incorporated.
95 Main Road,
TAPAWERA 7096

Detailed seismic assessment of existing building – 95 Main Road, Tapawera

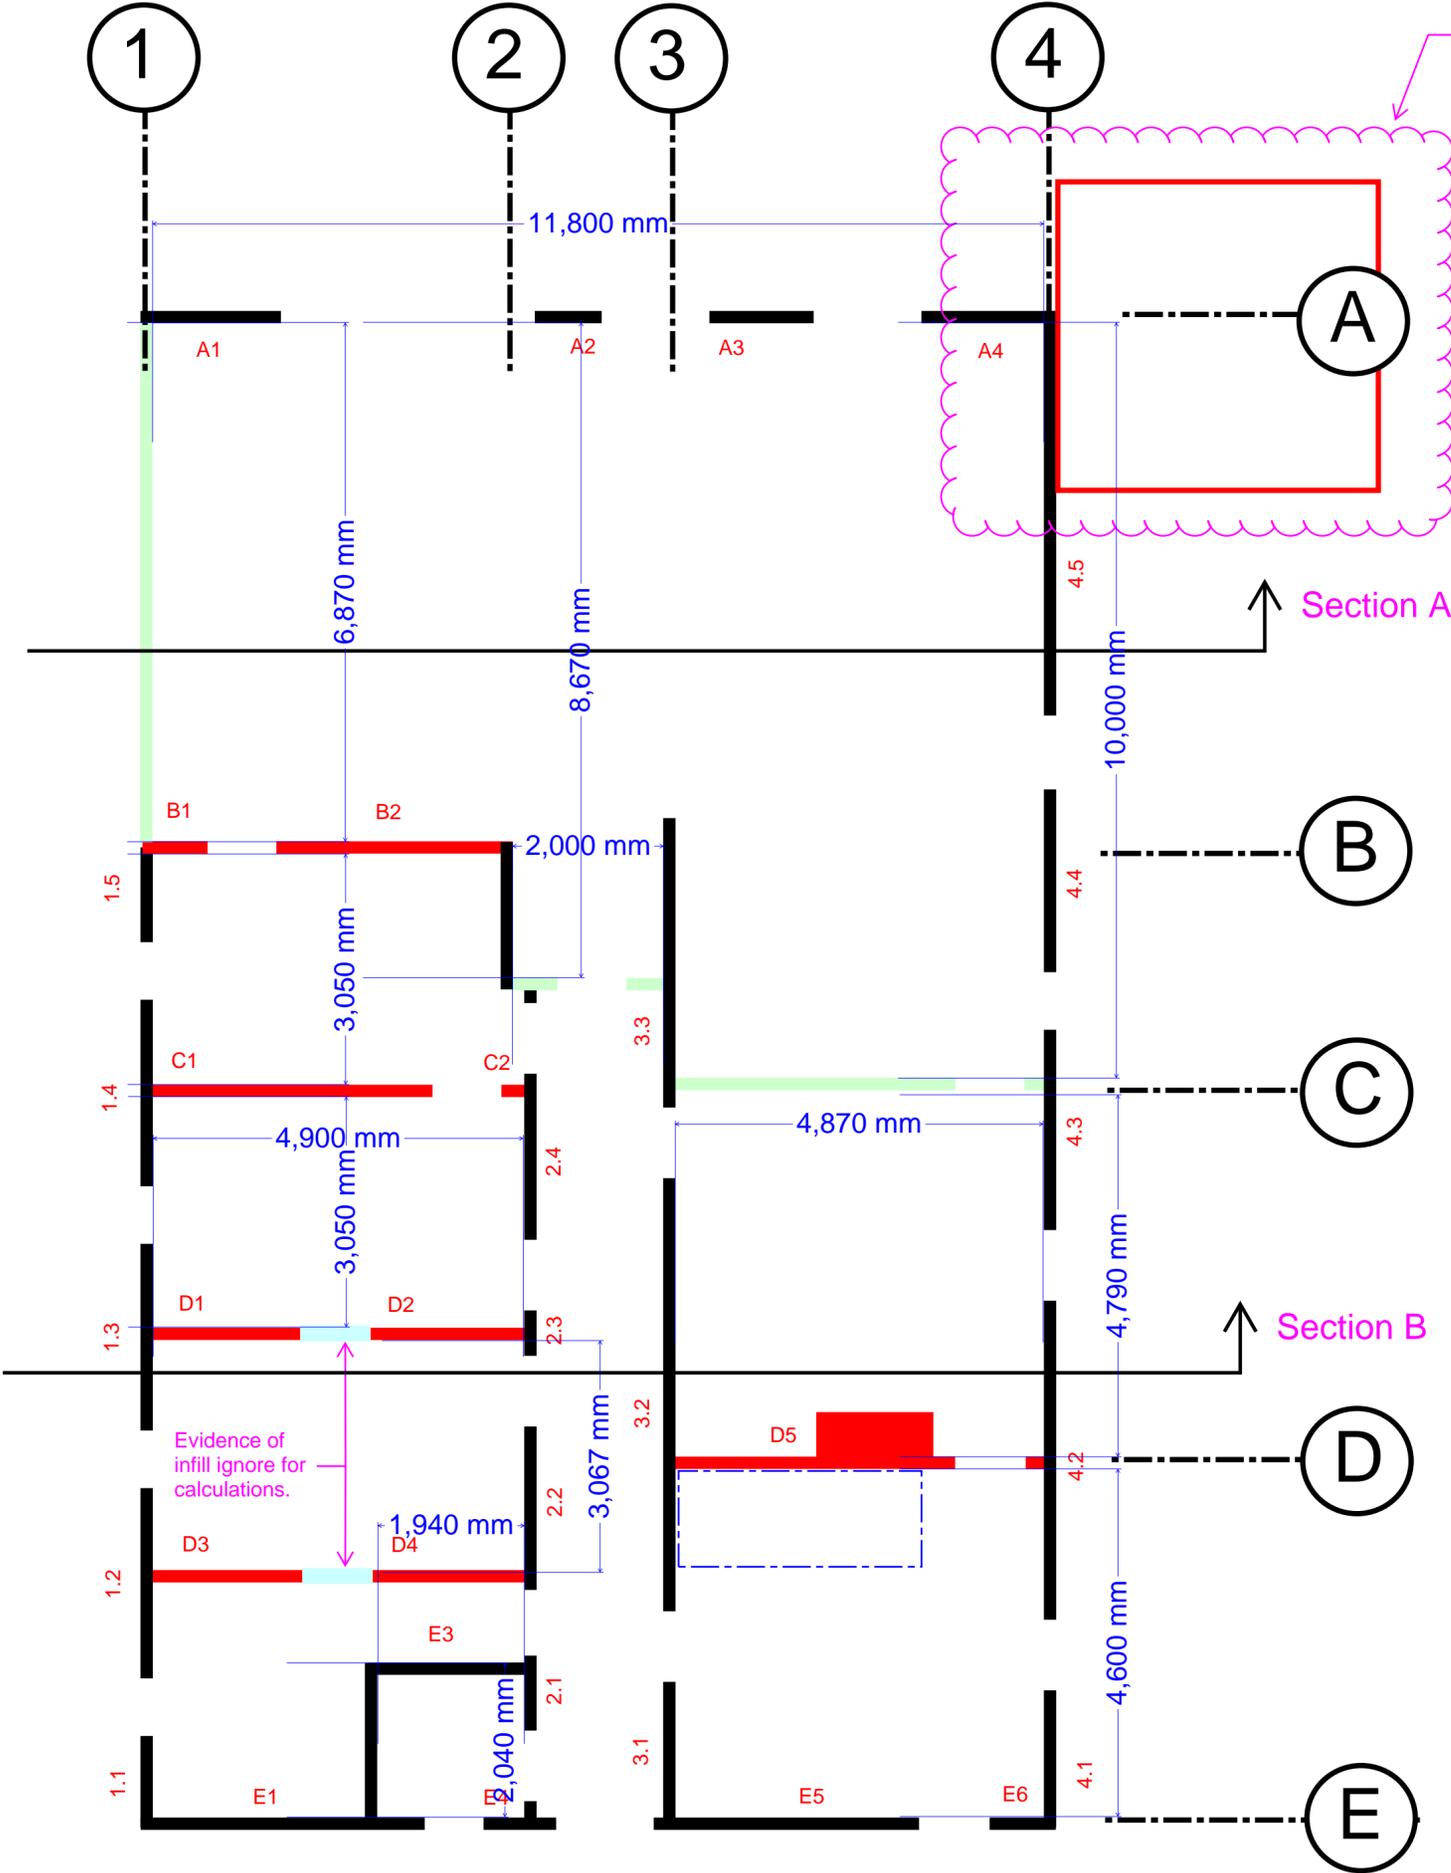
General Markup:

Area not able to be inspected internally.

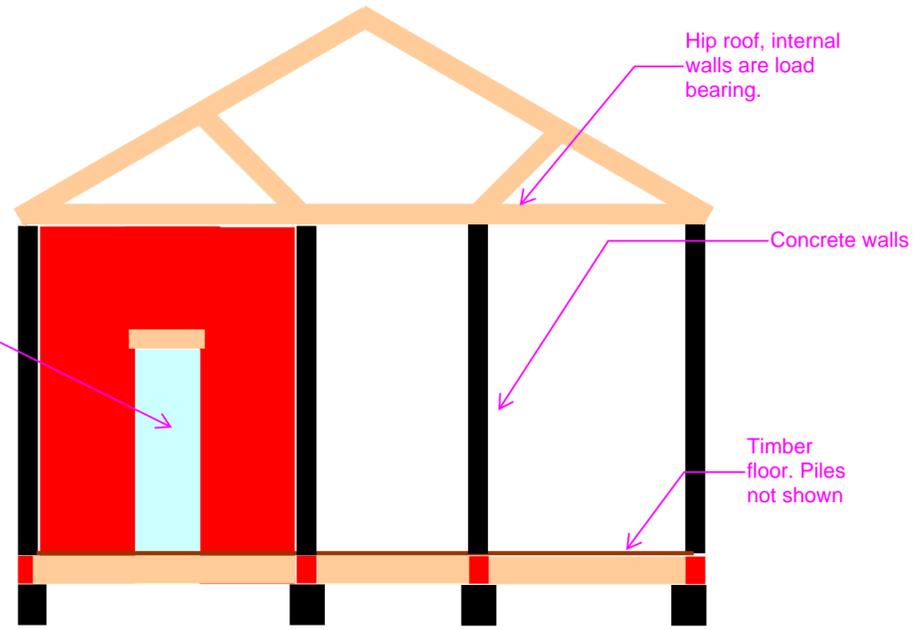
Section B - PITCHED ROOF

Concrete strip footings with brick above and concrete walls above that

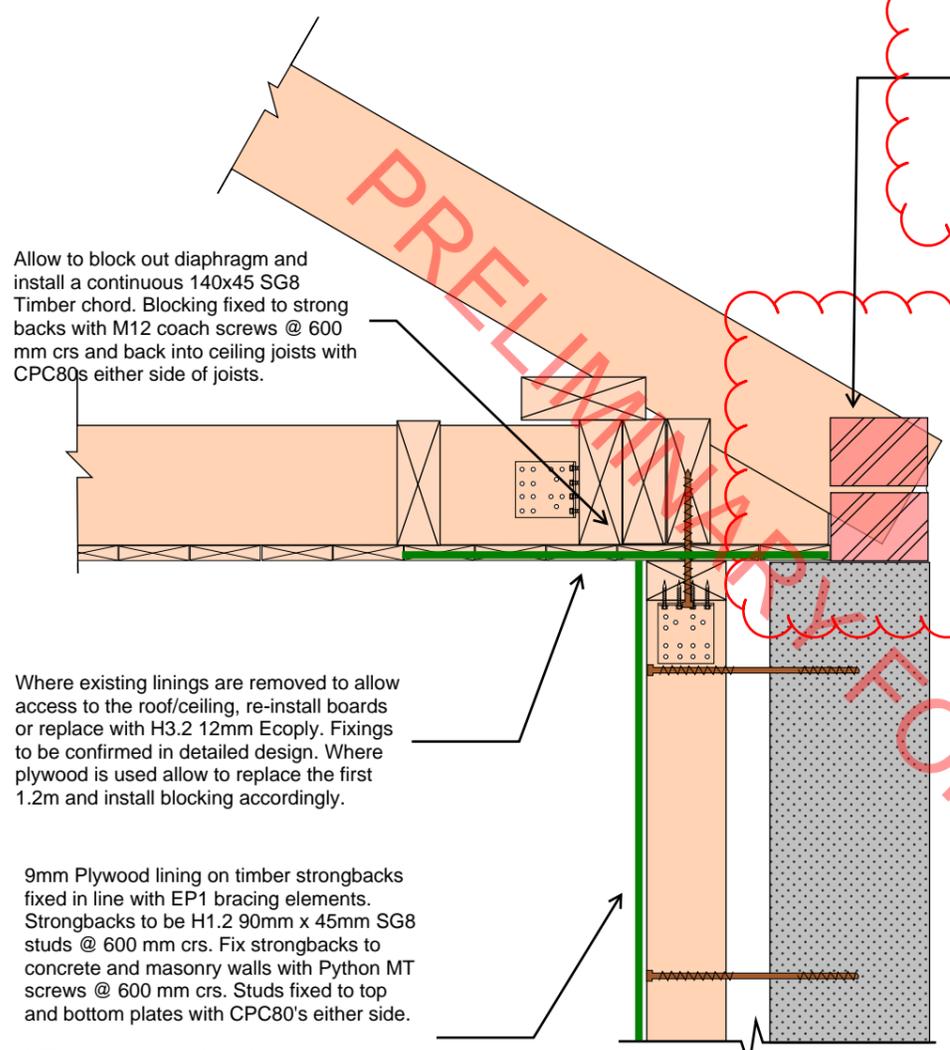
STRONGBACK TO 180MM CONCRETE WALL AND DIAPHRAGM CONNECTION UPGRADE.

QS Needs to allow contingency
Currently there is limited information on the construction between the eaves and concrete walls. Brick was observed on site this will need to be investigated further. Additional strengthening may be required.

Allow to block out diaphragm and install a continuous 140x45 SG8 Timber chord. Blocking fixed to strong backs with M12 coach screws @ 600 mm crs and back into ceiling joists with CPC80s either side of joists.

Where existing linings are removed to allow access to the roof/ceiling, re-install boards or replace with H3.2 12mm EcoPLY. Fixings to be confirmed in detailed design. Where plywood is used allow to replace the first 1.2m and install blocking accordingly.

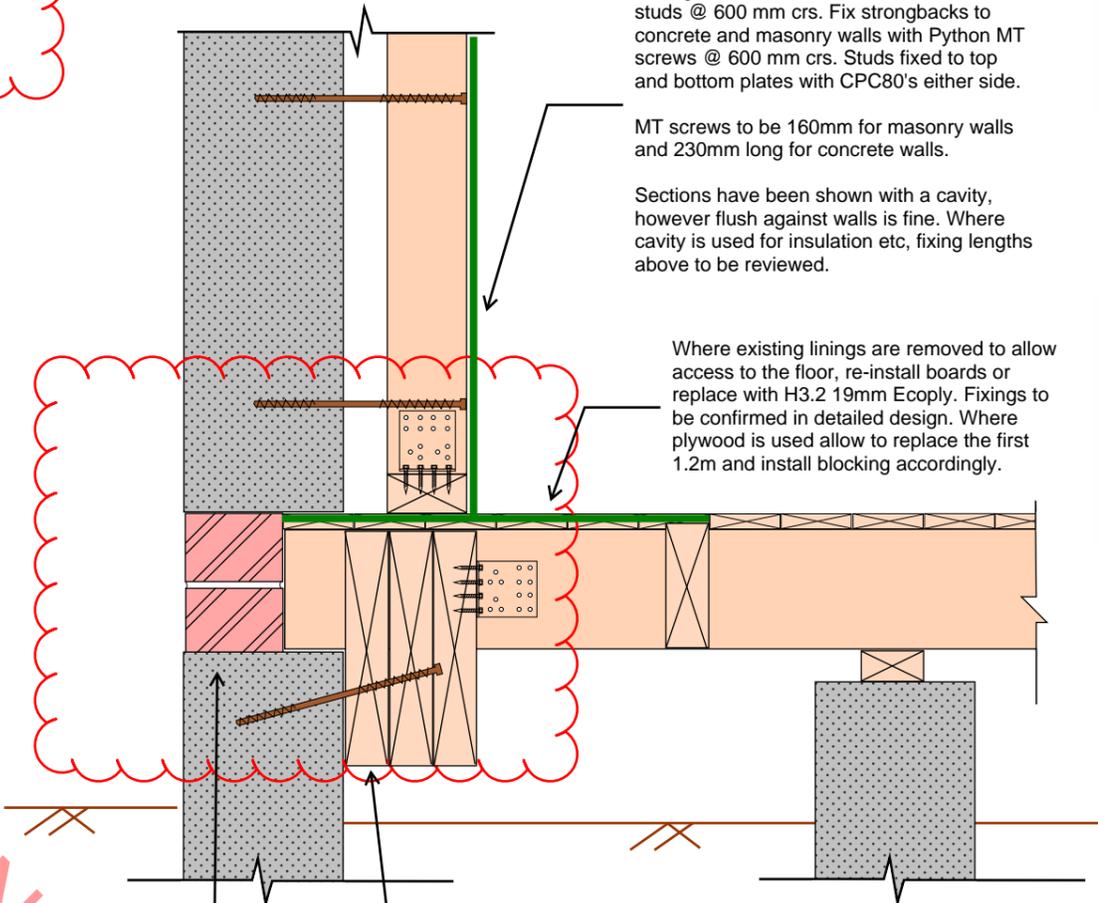
DETAIL 2 - STRONGBACK TO CONCRETE WALL AND FOUNDATION

QS Needs to allow contingency
Currently there is limited information on the construction between the foundations and the upper concrete walls and the exact height of brick. Additional strengthening may be required.

Where existing linings are removed to allow access to the floor, re-install boards or replace with H3.2 19mm EcoPLY. Fixings to be confirmed in detailed design. Where plywood is used allow to replace the first 1.2m and install blocking accordingly.

Allow to fix a timber stringer/blocking to all strip footings to tie strong backs and footings together. Allow for python MT fixings central in blocking member or @ 600 mm crs along the stringer length. Timber minimum size 190 mm SG8 and H4. Fix back to timber floor joists with CPC80s either side of joist.
